# BUCKEYE LAKE DAM HISTORY, EVALUATION, REMEDIATION

DANIEL P. STARE  
DR. DONALD A. BRUCE

61<sup>ST</sup> AEG Annual Meeting  
13<sup>th</sup> IAEG Conference  
San Francisco, CA  
September 2018

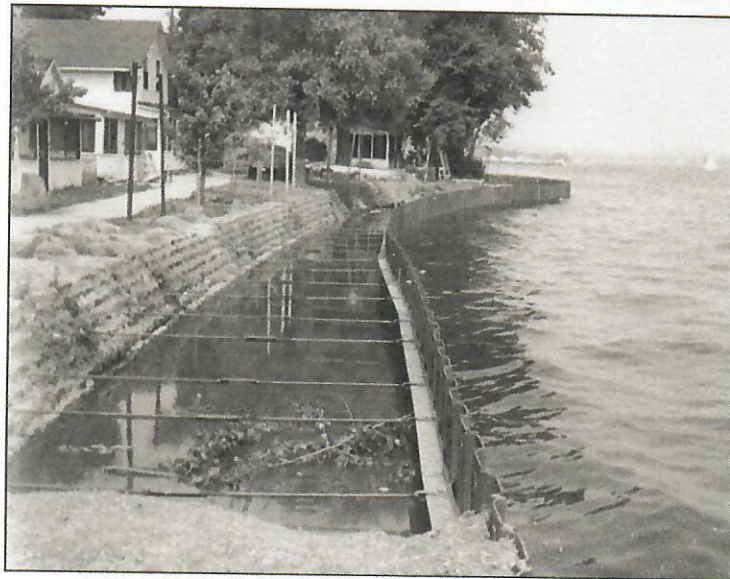
## Various Phases Late 1940's and Beyond

### • Shoreline Improvements

- Flat sheet piling installed upstream of dam
- Waler with tendons extend to reaction piles / deadmen
- Backfilled with bank run material
- Sheet piling installed at various phases beginning in the late 1940's

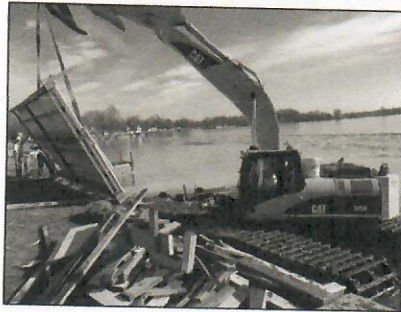
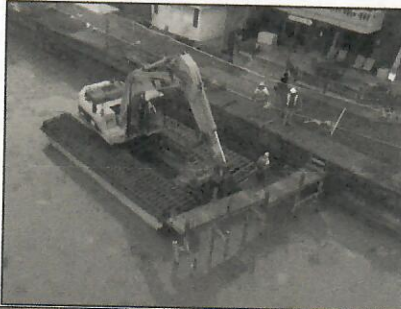
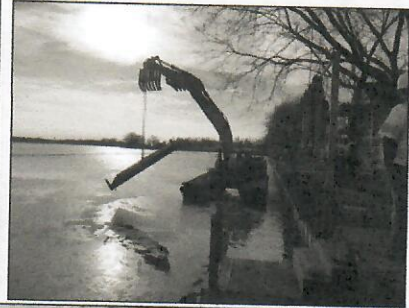
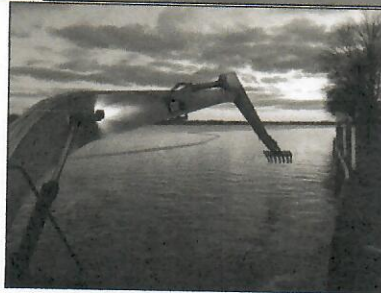
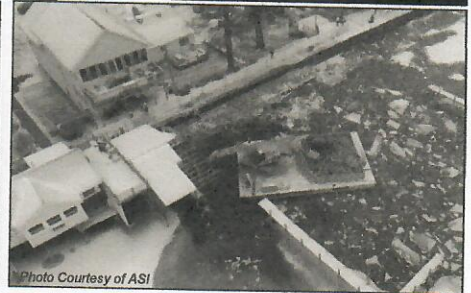
## IRRM Construction – Boat Docks and Foundation Prep

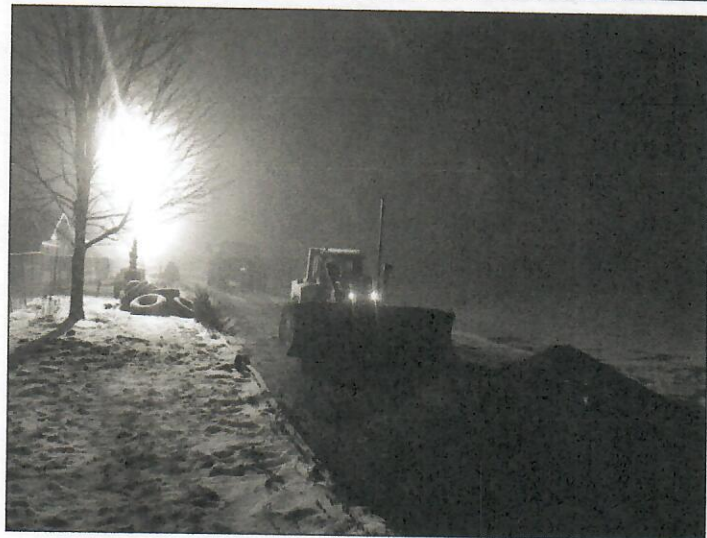
## IRRM Construction – Embankment Stability Berm

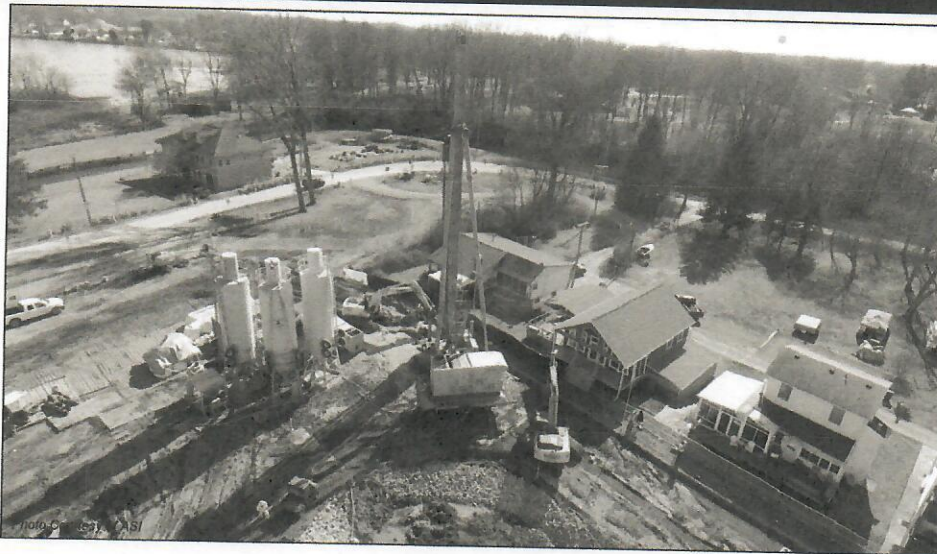
## IRRM Construction – Soil Mixed Cutoff Wall

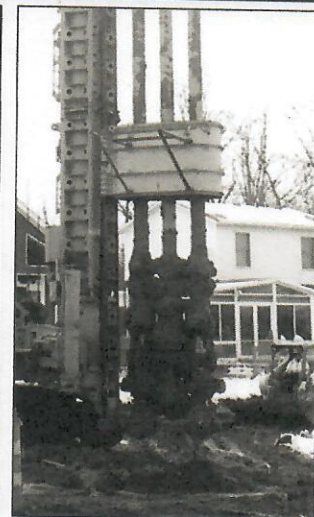
## IRRM Construction – Soil Mixed Cutoff Wall

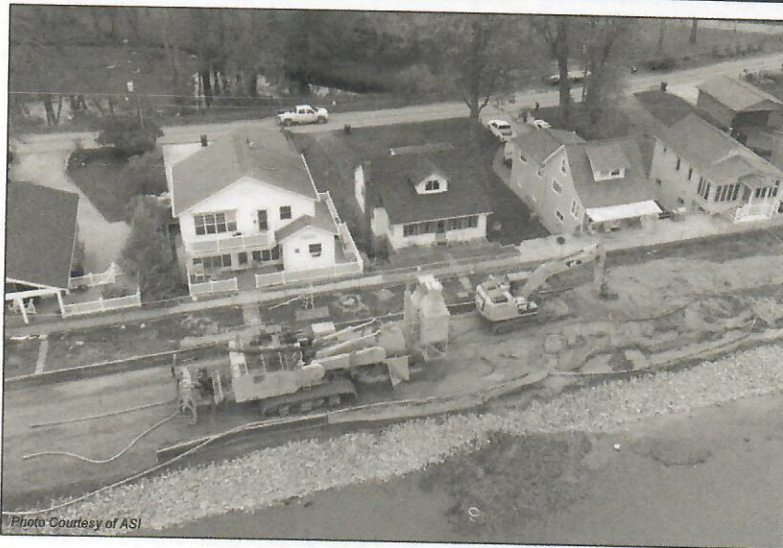
## IRRM Construction – Soil Mixed Cutoff Wall

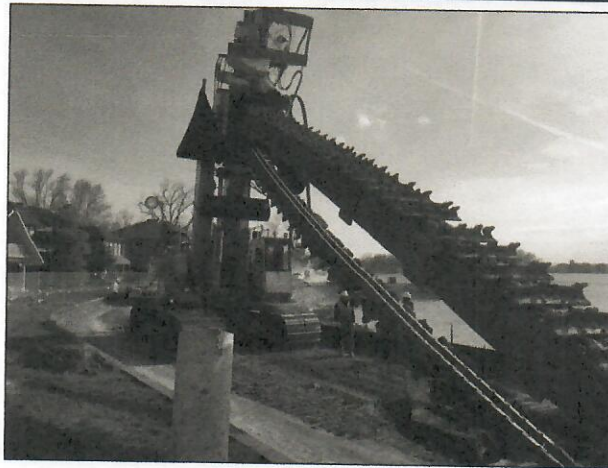
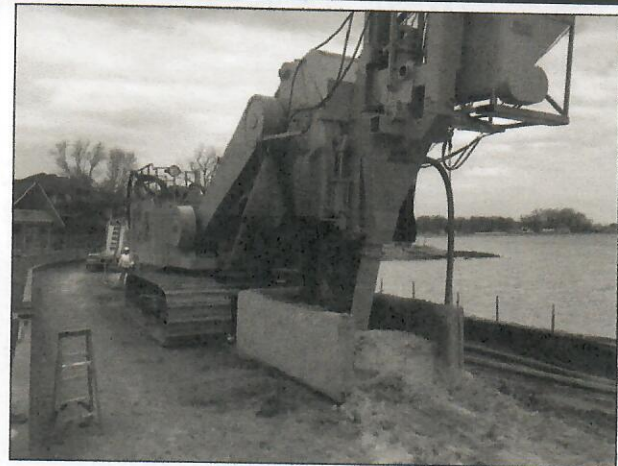
## IRRM Construction – Soil Mixed Cutoff Wall

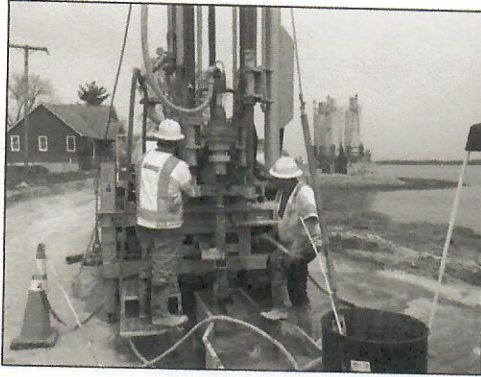
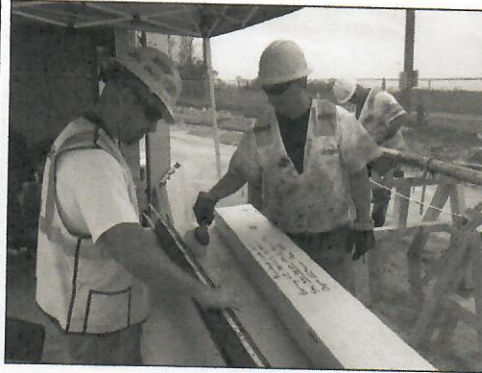
## IRRM Construction – Soil Mixed Cutoff Wall

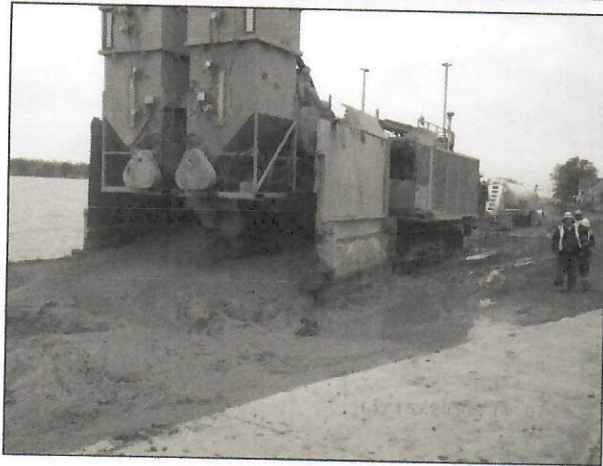
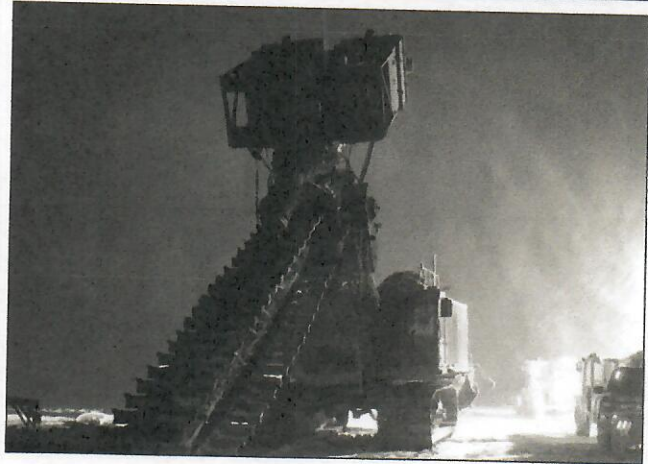
## Phase 2 Construction – Soil Mixing

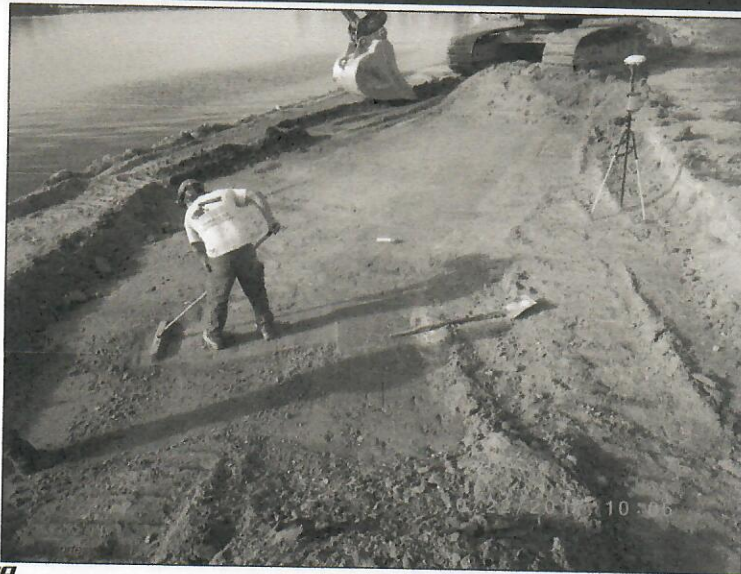
## Phase 2 Construction – Soil Mixing

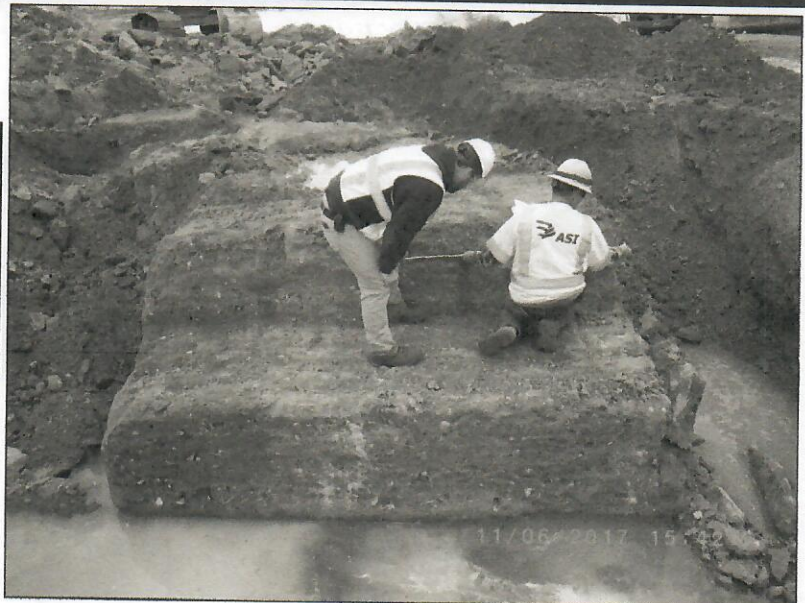
## Phase 2 Construction – Soil Mixing

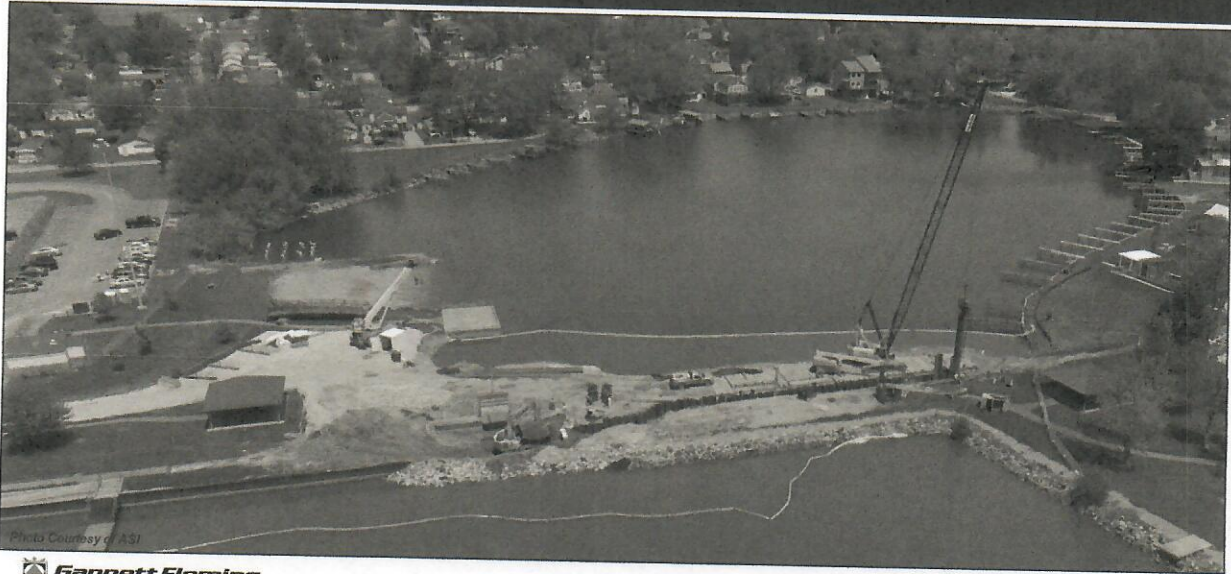
## Phase 2 Construction – Sheet Piling

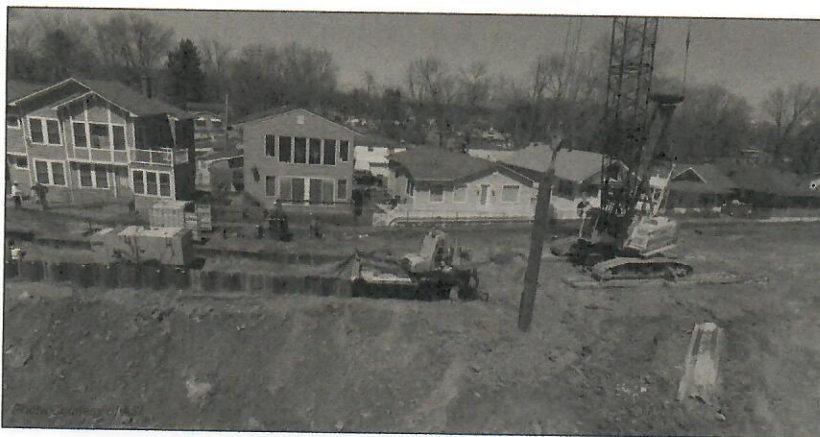
## Phase 2 Construction – Sheet Piling

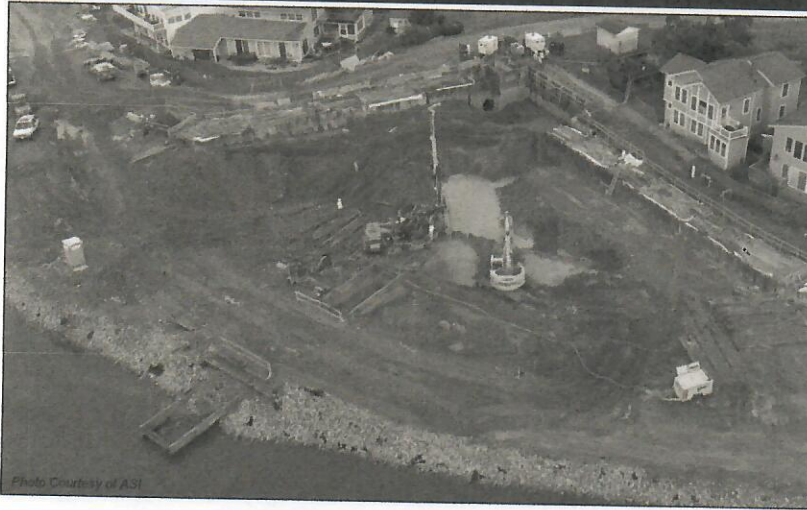
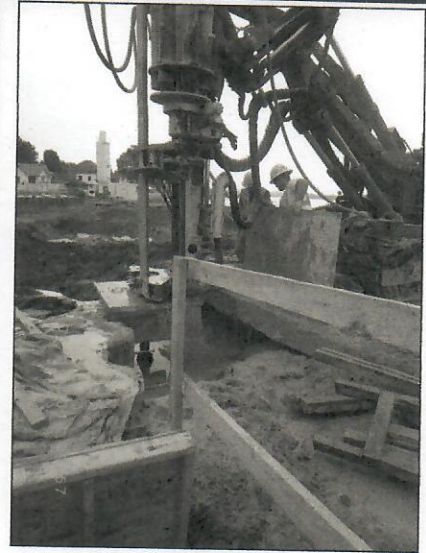
## Phase 2 Construction – Jet Grouting

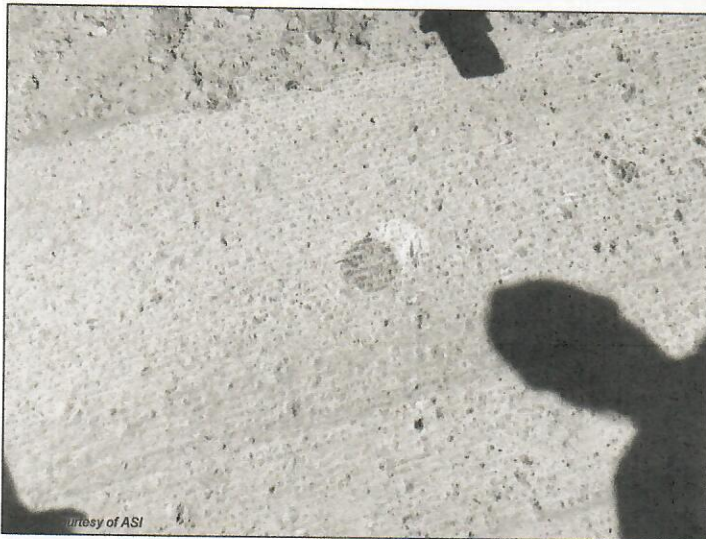
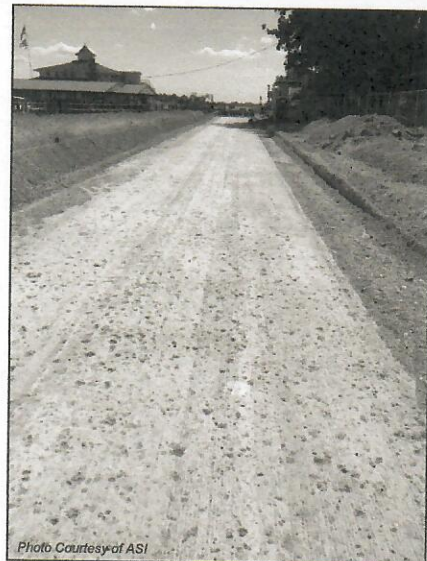
## Phase 2 Construction – Cap Construction

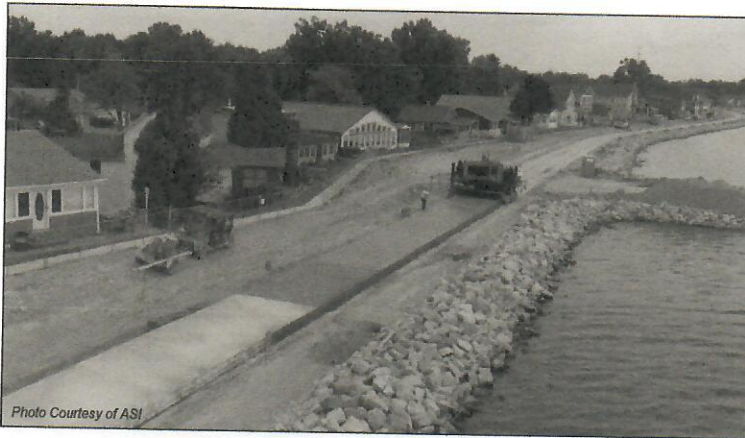
## Phase 2 Construction – Cap Construction

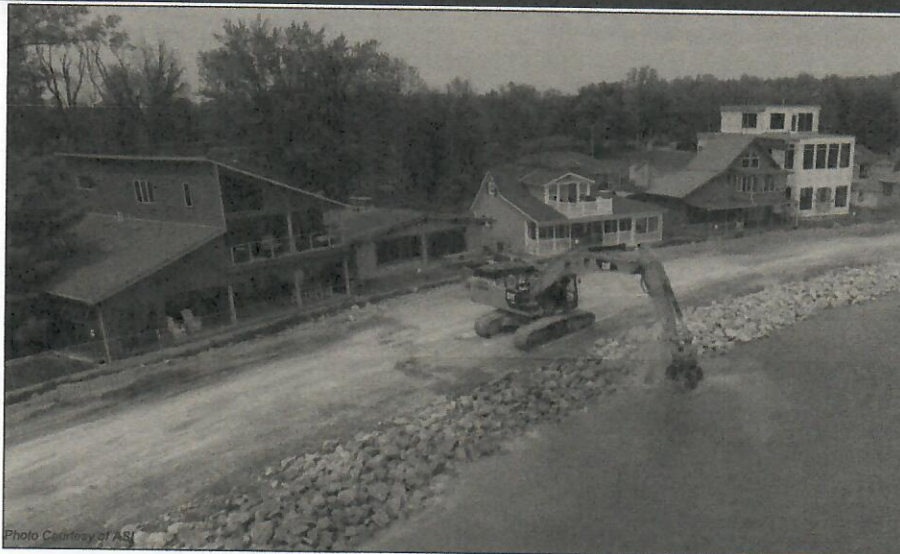
## Phase 2 Construction – Rip-Rap Placement

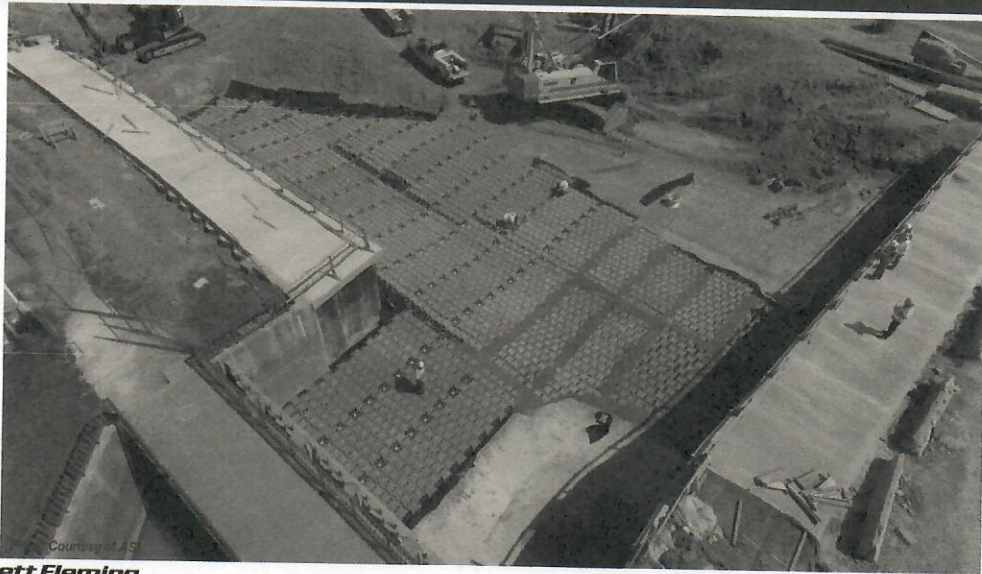
## Phase 2 Construction – Amil Spillway

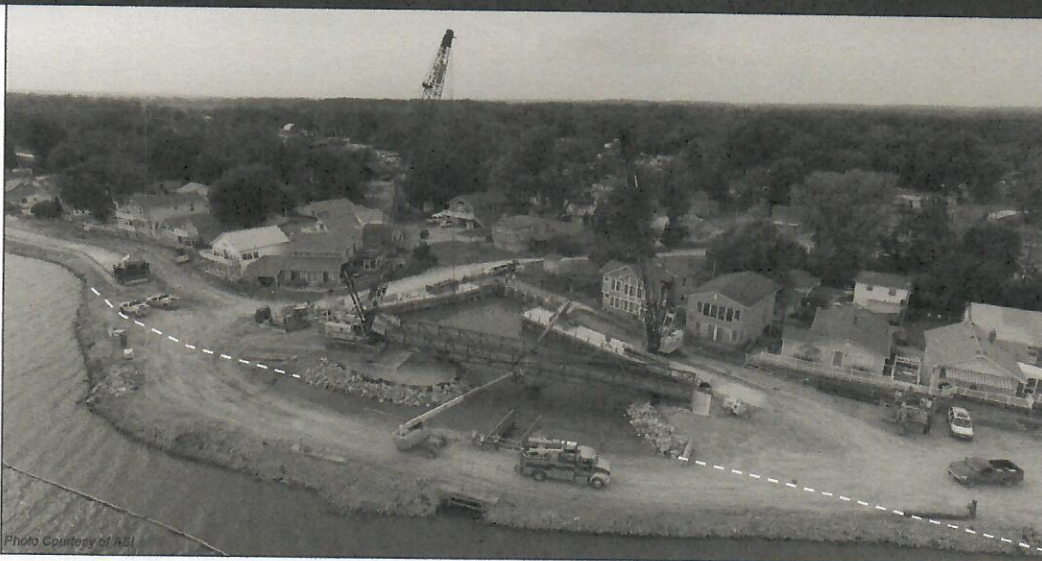
## Phase 2 Construction – Amil Spillway
