# **PORTAGE LAKES, OHIO – EAST RESERVOIR DAM: HISTORY, EVALUATION AND REMEDIATION**

## **ABSTRACT**

East Reservoir Dam is a high-hazard, sand fill embankment located just south of Akron, Ohio that is owned and operated by the Ohio Department of Natural Resources (ODNR). The dam was constructed in the 1830's as part of the feeder system for the Ohio and Erie Canal system. The dam is approximately 1,300 feet long and has a maximum height of 23 feet. There is significant residential development around the lake and a heavily-traveled road, Portage Lakes Drive, runs along the crest of the embankment.

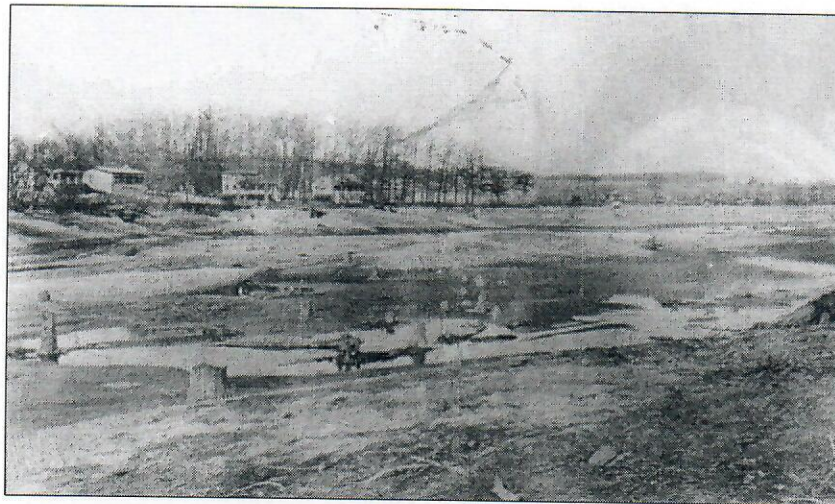
Figure 2. Photo showing East Reservoir drained after 1913 dam failure  
(Photo courtesy of Cuyahoga Falls Library)

Figure 2 shows a photograph of East Reservoir, after the breach in 1913. Although records are sparse, the available information suggests that the portion of the East Reservoir dam that failed and was rebuilt soon thereafter with the addition of the current north spillway in 1915. After the 1913 flood, the canal system was for all intents and purposes abandoned due to the extensive damage to the system. The reservoirs of Portage Lakes remain and are today used primarily for recreational purposes. In 1989, management of the reservoir system was transferred to the Department of Natural Resources.
